## Background

Sal Creek is a small coastal watershed on Prince of Wales Island that has supported heavy timber harvest. Over 15 miles of road were built in the watershed and one third of the timber, including the entire floodplain, was harvested between 1966 & 1971. Effects of this past management include landslides, wide-spread red alder regeneration along streams, establishment of reed canary grass along streams and ponds, erosion and sedimentation from roads in the floodplain, culverts that block fish passage and stream flow, poor deer winter range, and increased beaver activity, which in turn lead to blockage of the main stem, destabilization of the overflow channels, and less complex fish habitat. The watershed supports over 8 miles of perennial streams and historically provided productive habitat for coho, pink and chum salmon, steelhead and cutthroat trout, and dolly varden char.

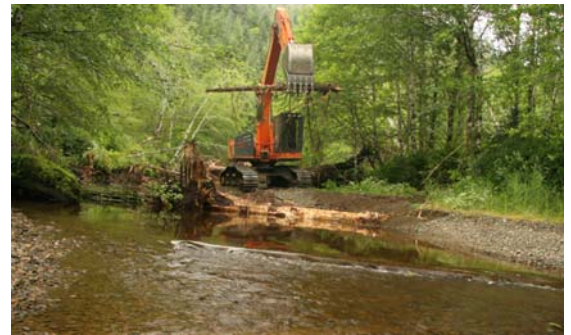
*Excavator working along Sal Creek creating an instream structure*

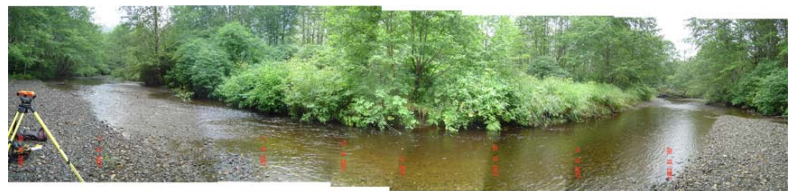
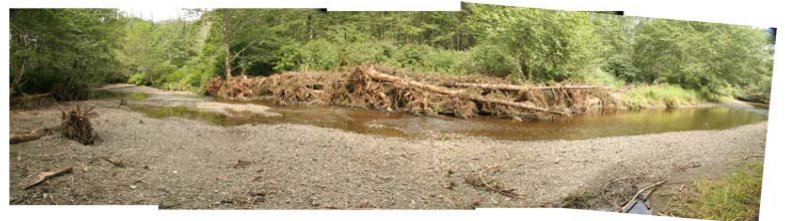
*Before restoration efforts (above), and after view of site showing armoring of stream bank and creation of scour pool and cover habitat.*

**Successes** Tributaries blocked by road fill and log culverts were reconnected to the mainstem. Habitat complexity was improved, which in turn can support more and bigger fish. Project managers learned a lot about in-stream structure design and equipment capability, as well as how to coordinate government and non-government partners in contract preparation and oversight
